Manhole Inspection Summary

Manhole # S41G__025MH

Insp Date: **3/18/09 12:04 PM**

Location Address: **1401 E PRATT ST**

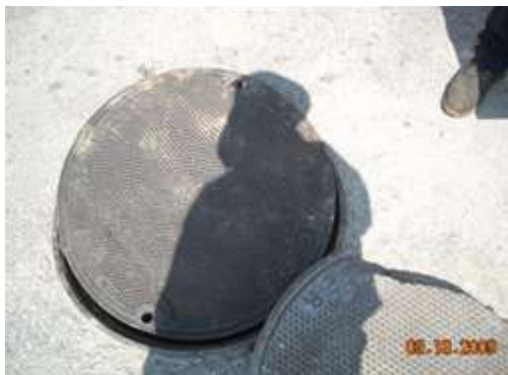
MISC.

Comments **BROKE AND REPLACED COVER TO COMPLETE INSPECTION (see photos)**

REPLACED BROKEN COVER

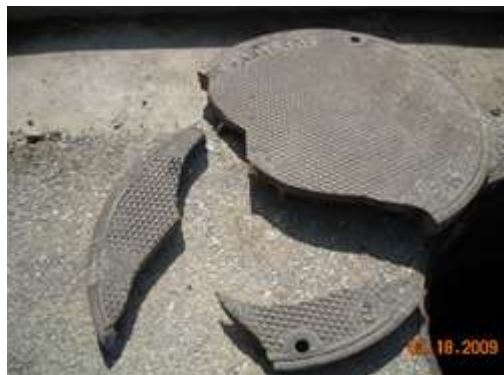
MISC.

BROKE COVER TO GAIN ACCESS

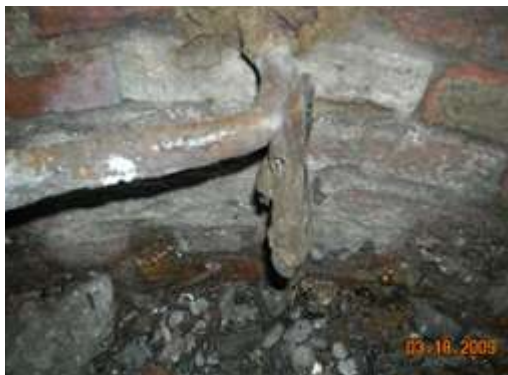
Defect 6

☒ **Evidence Of Surcharge** Depth: **4** (ft.) ☐ Active Surcharge Present

EVIDENCE OF SURCHARGE

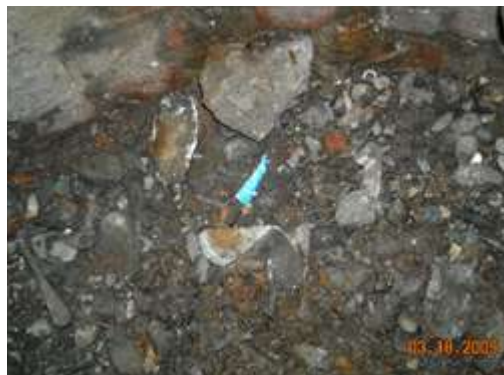
Defect 5

Condition: ☐ Sound ☐ Cracked ☐ Root Intrusion ☐ Deteriorated ☐ Leaks ☒ **Debris**

DEBRIS ON BENCH

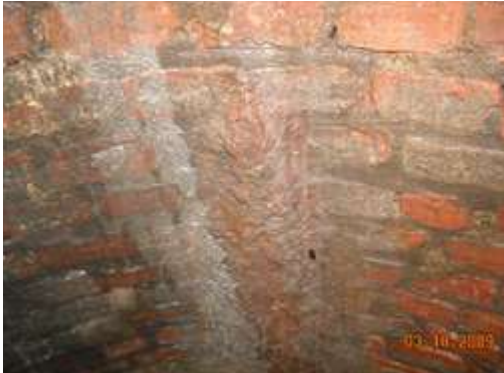
Defect 4

Condition: ☐ Sound ☐ Cracked ☐ Root Intrusion ☐ Loose Brick ☒ **Deteriorated**

DETERIORATION OF BARREL WALL,
INFILTRATION IN BARREL WALL

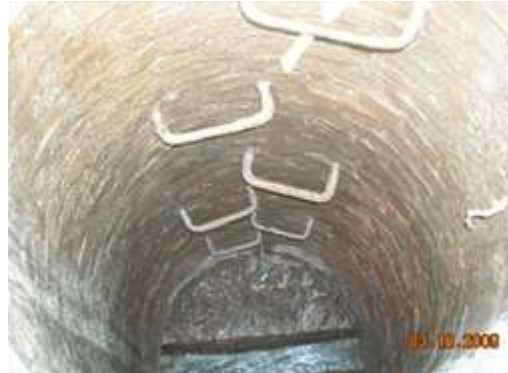
Defect 3

Count: **7** Missing: **0** ☒ **Corroded**

CORRODED STEPS

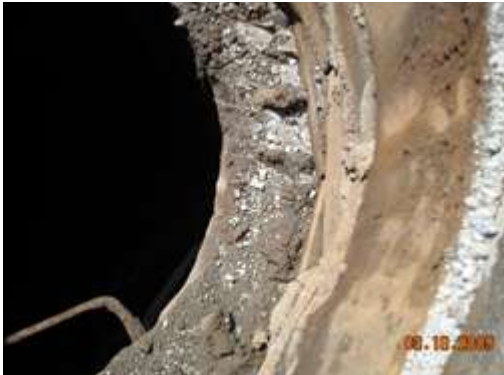
Defect 2

Offset: **4** (in.)

FRAME OFFSET

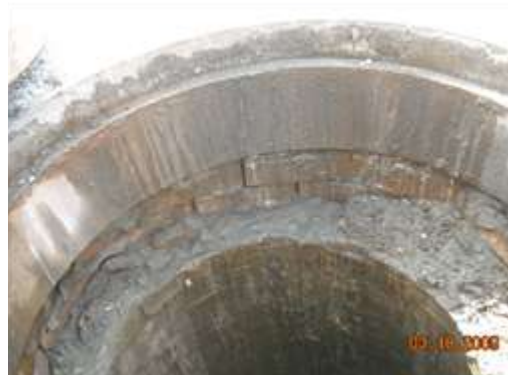
Defect 1

FRAME LEAKS, LOOSE BRICKS IN
CHIMNEY, CHIMNEY INFILTRATION

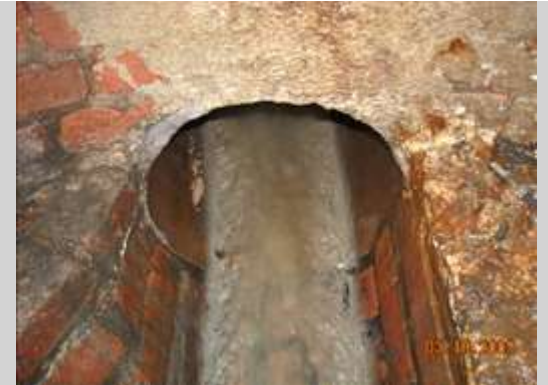
12 O'Clock Outflow

12 in. Circular Gravity Sewer
Pipe Out @ 12 O'Clock

Pipe Height: **12** (in.) Rod and Bar (Angled)
Pipe Material: **Clay** ☐ Pipe Lined
Invert Depth: **11.70** (ft.) Flow Characteristics: **Fast**
Deposits: ☒ None ☐ Mud ☐ Sludge ☐ Debris ☐ Grease
Silt Depth: **0** (in.) Deposits Extent:
Infiltration: **None** Pipe Seal Cond: **Sound**

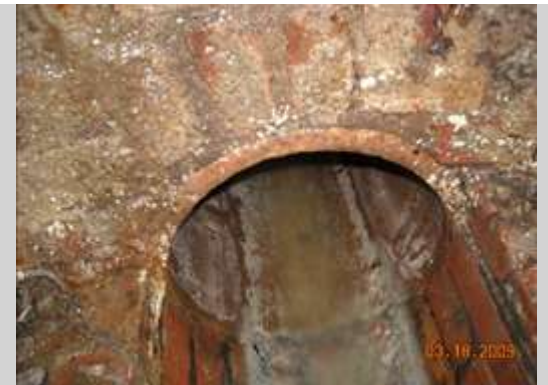
6 O'Clock Inflow

12 in. Circular Gravity Sewer
Pipe In @ 6 O'Clock

Pipe Height: **12** (in.) Rod and Bar (Angled)
Pipe Material: **Clay** ☐ Pipe Lined
Invert Depth: **11.65** (ft.) Flow Characteristics: **Fast**
Deposits: ☒ None ☐ Mud ☐ Sludge ☐ Debris ☐ Grease
Silt Depth: **0** (in.) Deposits Extent:
Infiltration: **None** Pipe Seal Cond: **Sound**

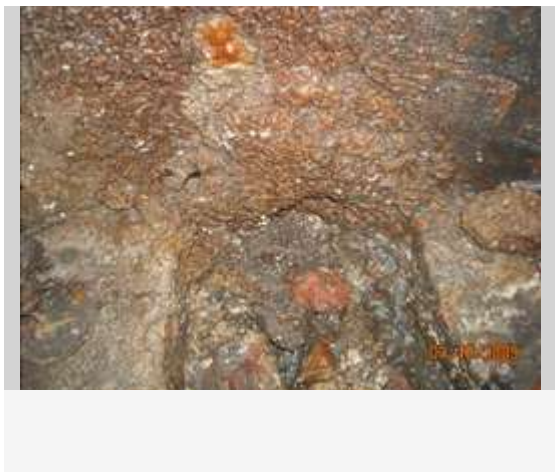
9 O'Clock Inflow

0 in. Circular Gravity Sewer
Pipe In @ 9 OClock

Connects To: **Stub connection / abandoned**
☐ Possible Illicit Connection
